CLASSIC LAND ROVER

WARNING LIGHT

THE LITTLE BLUE LIGHT

Michael Shaw restores the main beam indicator light to his Series IIA

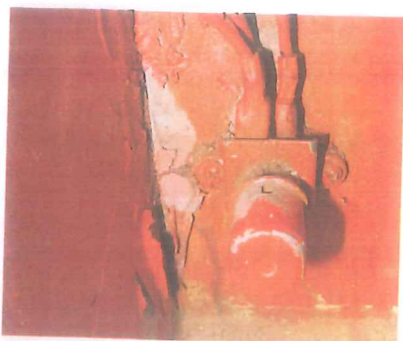
The wires leading to the dip switch had been painted over, so I scraped off the red paint. The true wiring colours were as shown as correct per the standard wiring diagram and the Richard Hall book. I next unscrewed the metal dash and confirmed the bulb wiring colours to be correct. A continuity tester proved the switch was broken despite the clean terminals.

1. Defective dip switch, wires painted over in red

I ordered a replacement dip switch from Rovers North in Westford, Vermont and swapped it in.

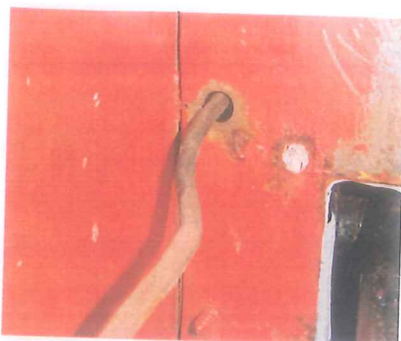
dip switch. They exited the firewall through a rusted hole which was missing a rubber grommet. Rain must have used the wiring as a water conduit straight down to the dip switch. I checked the spade connectors and the dip switch terminals and found all

2. A rubber grommet is missing at the wiring hole in the firewall. A source for leaking water

To protect the wiring in future, I re-installed a rubber grommet and sealed some additional rainwater entry points where rivets and bolts had gone missing.

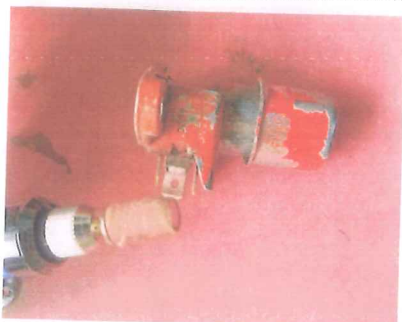
4. Cleaning electrical contacts made easy

In my compact electrical kit, I carry a gizmo which is like a portable Dremel tool. This battery-operated manicurist's tool lacks torque, but it certainly has plenty of spinning power to scrape and burnish contact points. It was easy for me to clean the dip switch terminals and spade connectors. In about two minutes' time, everything looked shiny and clean, and my headlamps worked again. But mysteriously, the little blue light on my dash remained unlit regardless of tapping the dip switch.

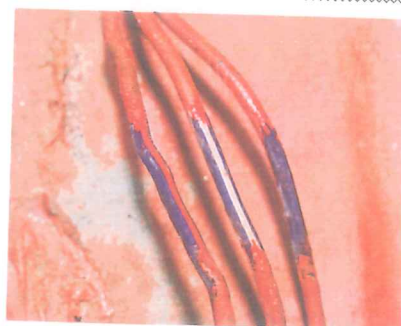
6. After scraping the paint off the wires, true colour codes are revealed: blue-red (L), blue-white (C), solid blue (R)

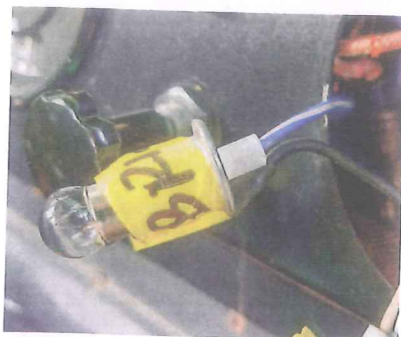
7. Blue-white wire goes into the main beam indicator bulb (232590). Black wire goes to ground

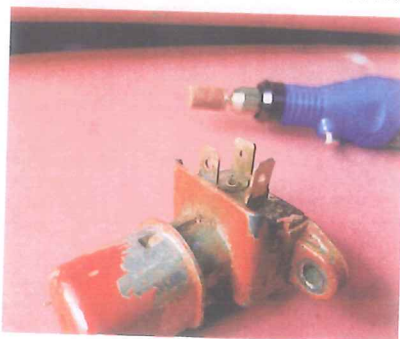
8. Broken dip switch. Contacts have been cleaned, but internal workings are corroded

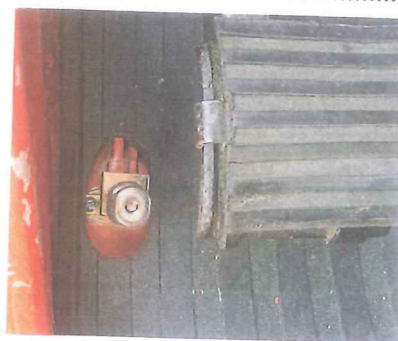
9. Shiny new dip switch from Rovers North installed

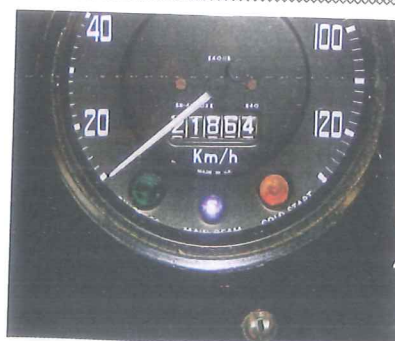
12. Blue dash indicator light is illuminated with main beams on. LED provides extra brightness
