CLASSIC LAND ROVER

WARNING LIGHT

THE LITTLE BLUE LIGHT

Michael Shaw restores the main beam indicator light to his Series IIA

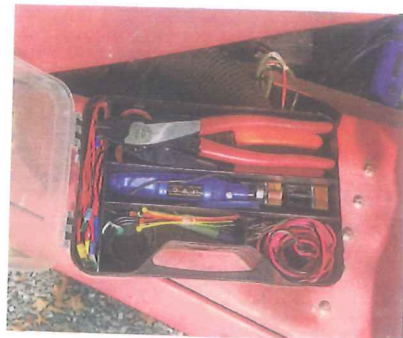
3. A manicurist's tool in my electrical kit (centre). This battery-operated device is great for cleaning electrical contacts

In my compact electrical kit, I carry a gizmo which is like a portable Dremel tool. This battery-operated manicurist's tool lacks torque, but it certainly has plenty of spinning power to scrape and burnish contact points. It was easy for me to clean the dip switch terminals and spade connectors. In about two minutes' time, everything looked shiny and clean, and my headlamps worked again. But mysteriously, the little blue light on my dash remained unlit regardless of tapping the dip switch.

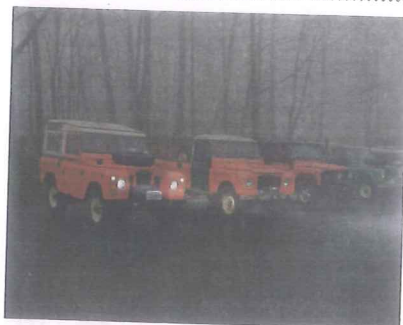
5. Elsa (left) arrives safely in the fog
